**Addendum Regarding 2016 Conditions at an Unauthorized Suction Dredging Site To
An Investigation of Stream Channel Modifications at Unauthorized Suction Dredging Sites
on the South Fork Clearwater River, October 7 and 8, 2015**

Dan Kenney
North Zone Fisheries Biologist
Nez Perce-Clearwater National Forests
February 3, 2016
Addendum Added May 12, 2017

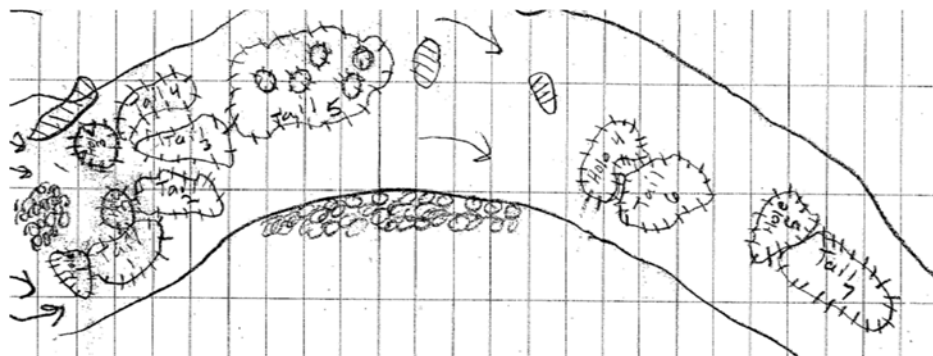
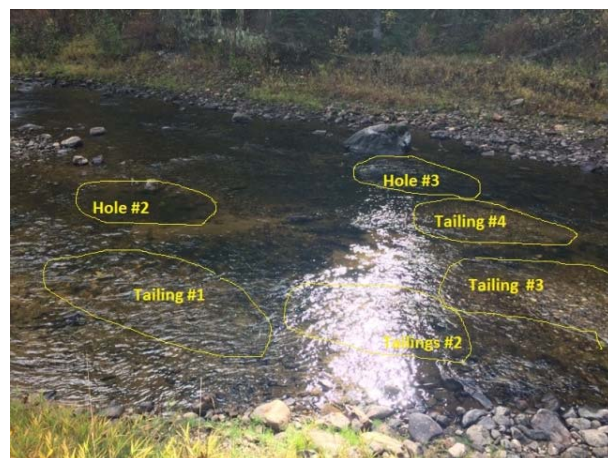
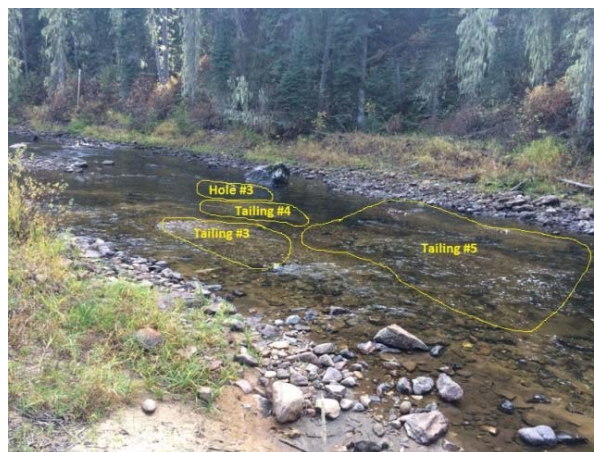
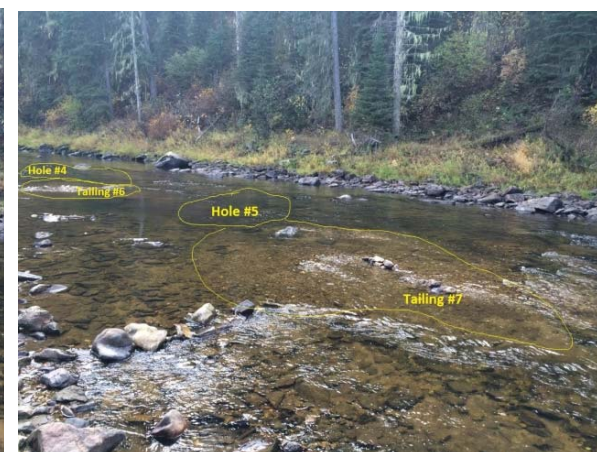
SFCR Unauthorized Site #14, October 8, 2015

Figure 1. Appendix A, Site 14, from February 3, 2016 original report

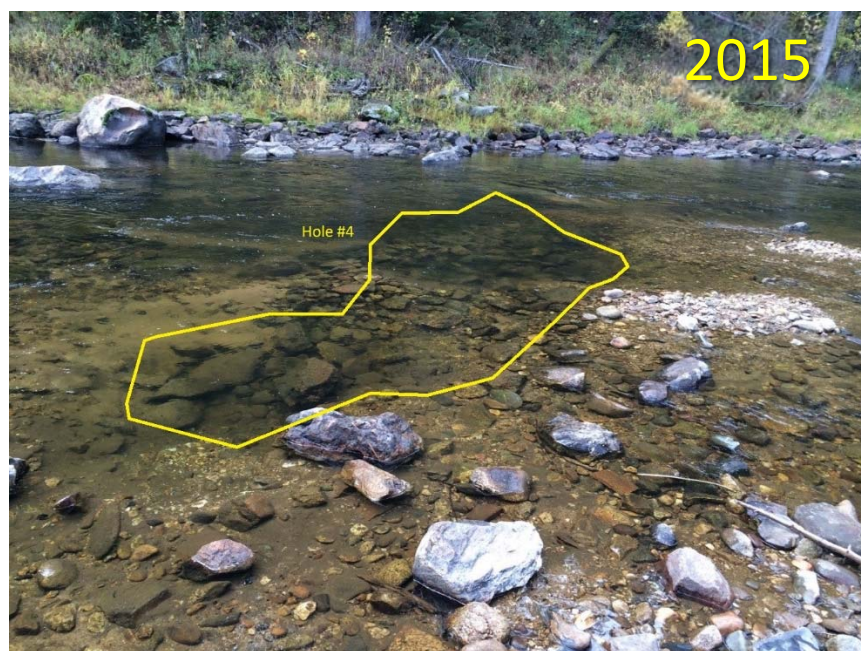
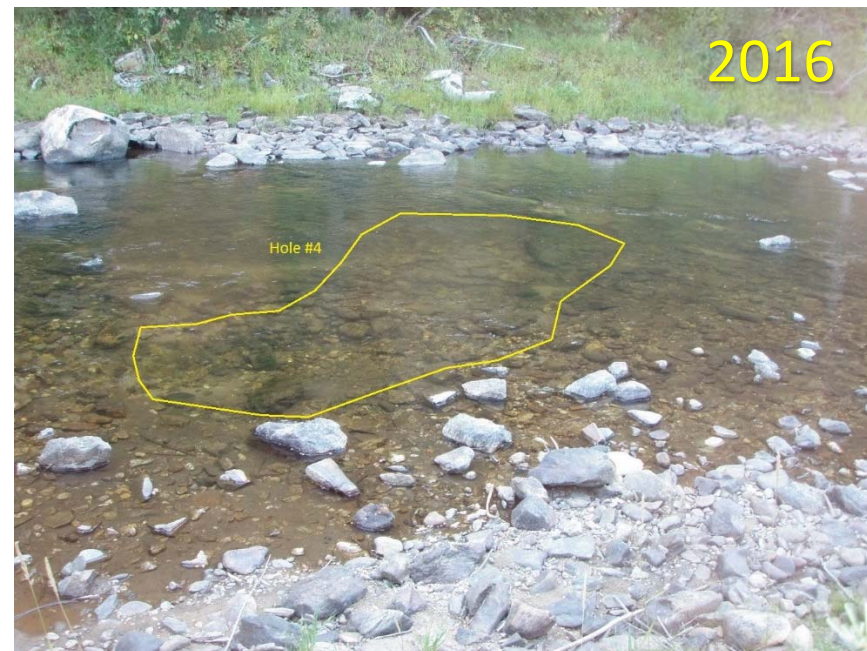
Length (m)		Width (m)		Depth (m)			Dredge Hole Totals		
		2015	2016	2015	2016	2015	2016	Holes Summed	2015	2016	Change
Site # 14	Hole #1	10.4	10.4	4.9	4.2	0.7	0.5	Area: (m^2):	146	102	-30%
	Hole #2	3.5	2.3	3.1	1.5	0.7	0.6	Adjusted Area (m^2):	116	82	-30%
	Hole #3	3.8	1.7	2.6	1.6	0.6	0.6	Adj. Area (ft^2):	1253	878	-30%
	Hole #4	6.3	5.4	7.9	5.8	1	0.7	Adj Volume (yd^3)	86	36	-58%
	Hole #5	5.6	5.8	4.3	3.6	1.1	0.8

Figures 2 and 3 (top). Approximate outline of dredge hole #4 at Site 14 in 2015 and 2016.
Figures 4 and 5 (bottom). Approximate outline of dredge hole #5 at Site 14 in 2015 and 2016.
